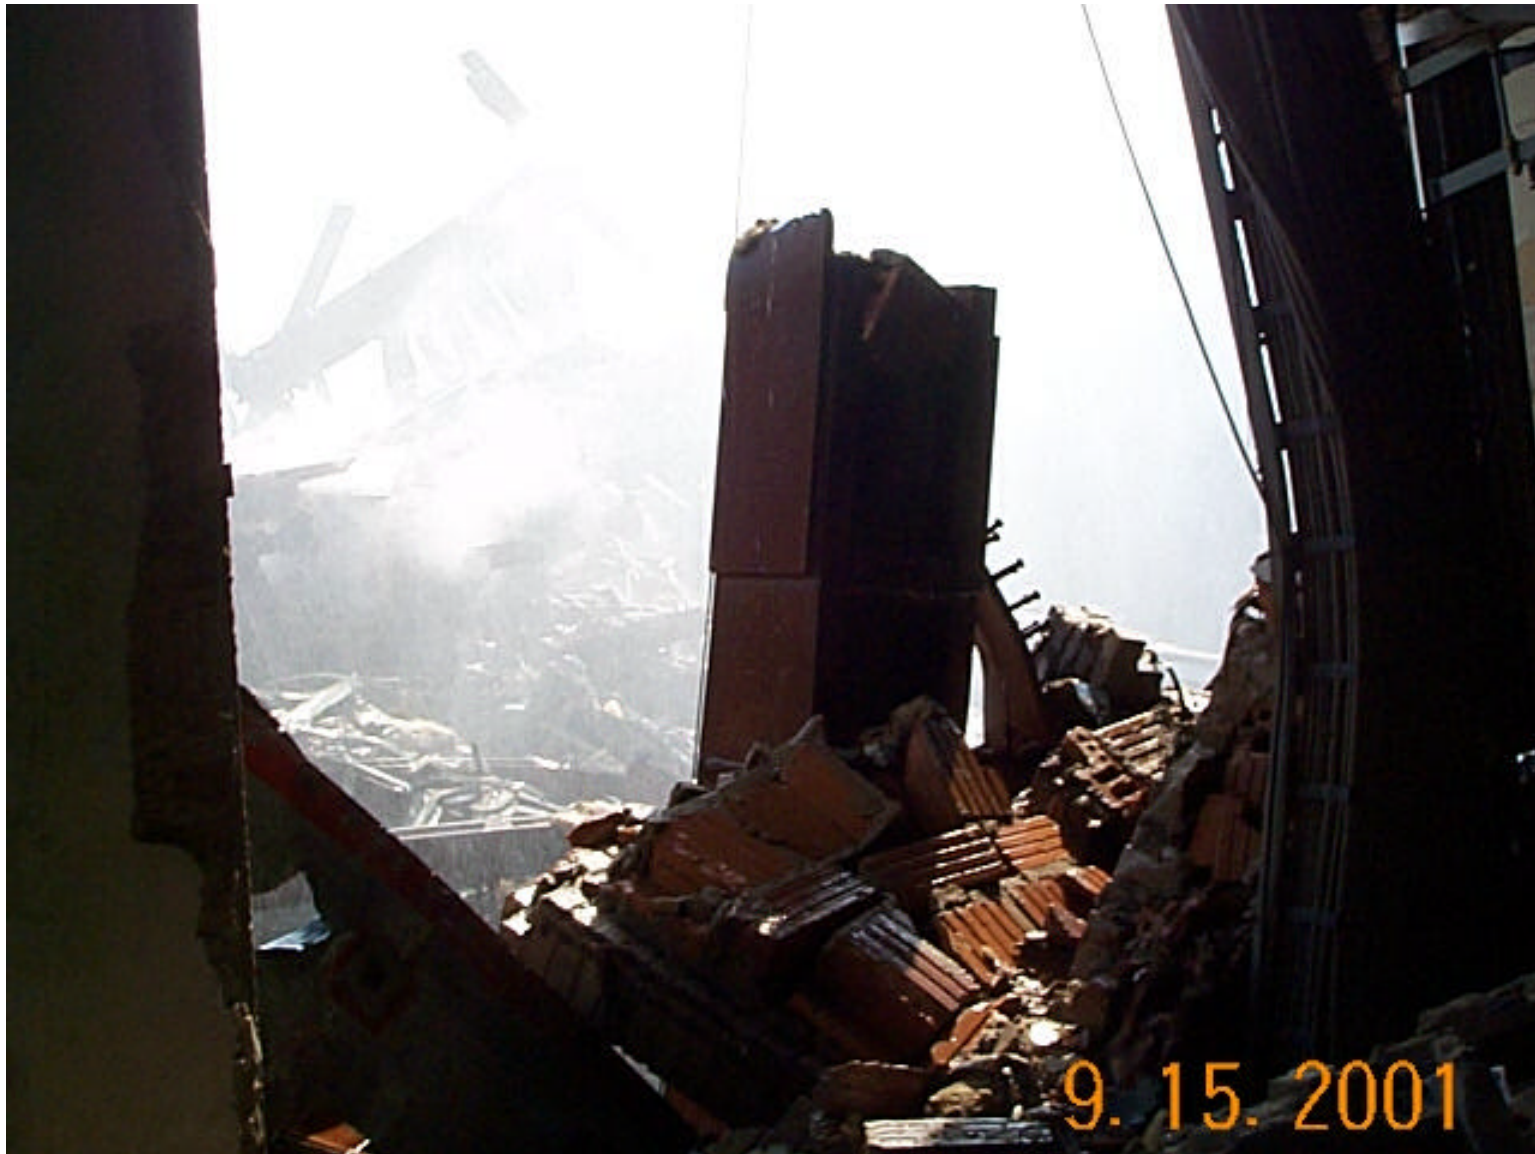
Looking out the southeast corner of 140 West Street.
DACS and Access equipment on the right.

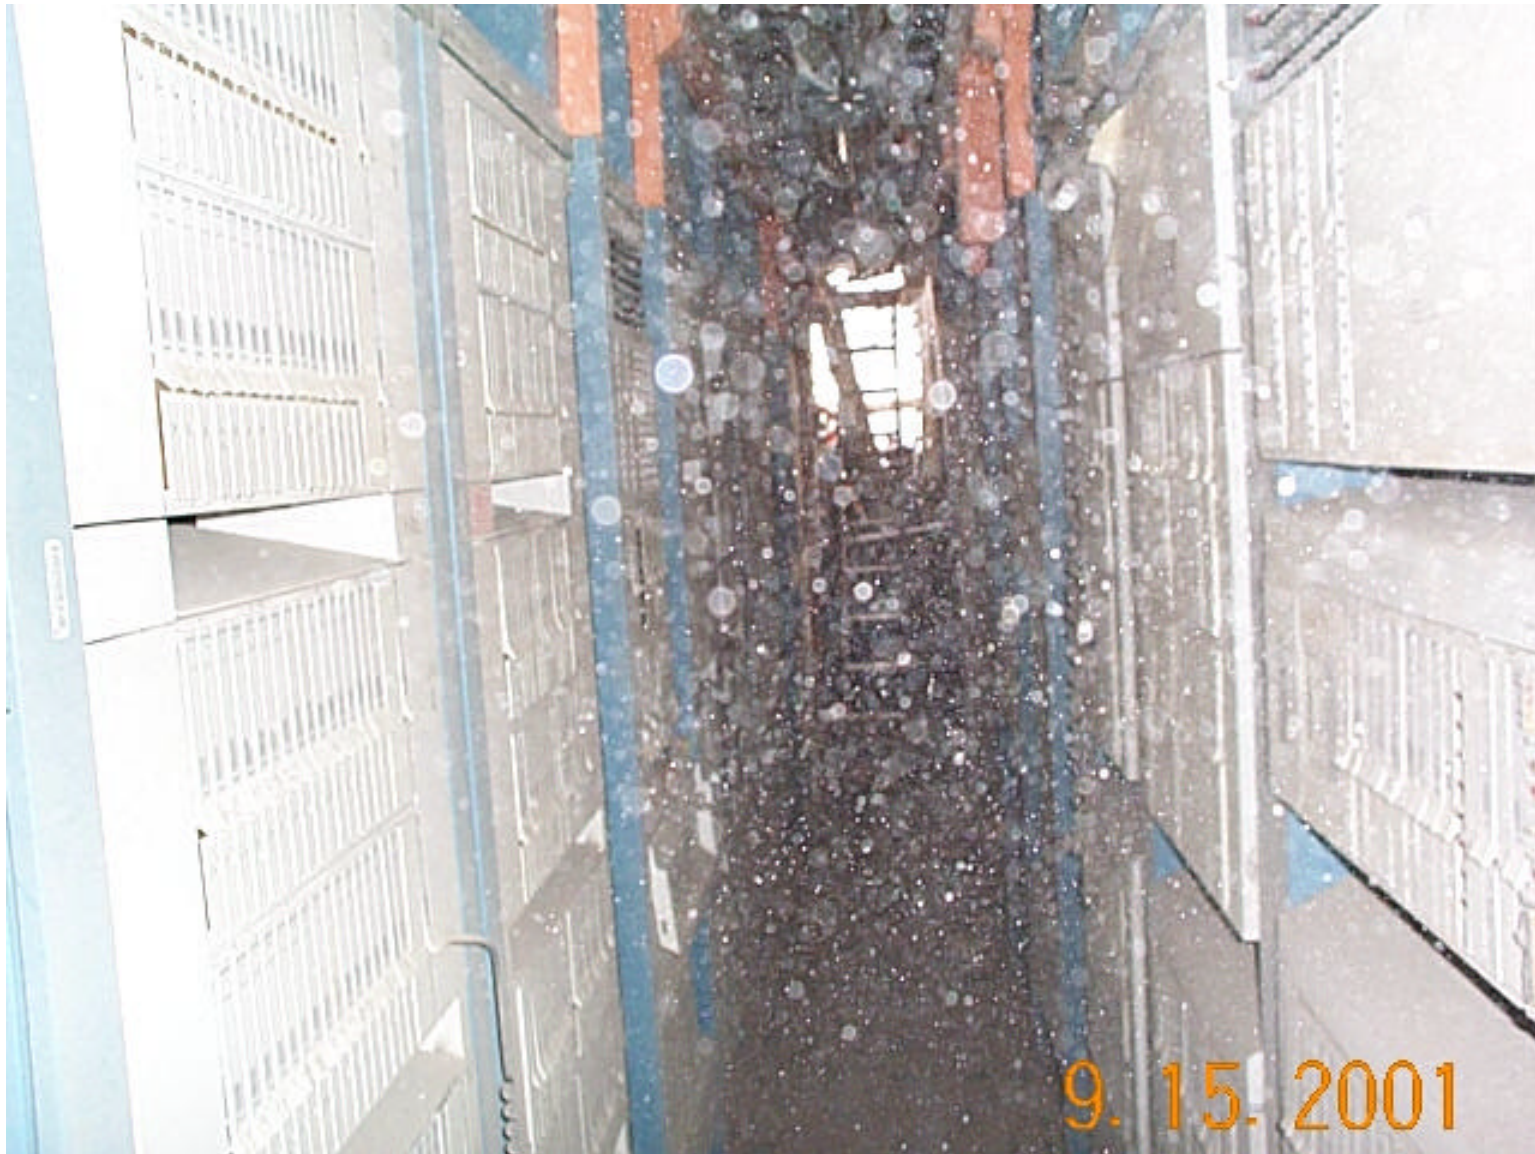
DACS III & IV Spots on the lens are from dripping water from above. Note hole in wall At the end of the isle.

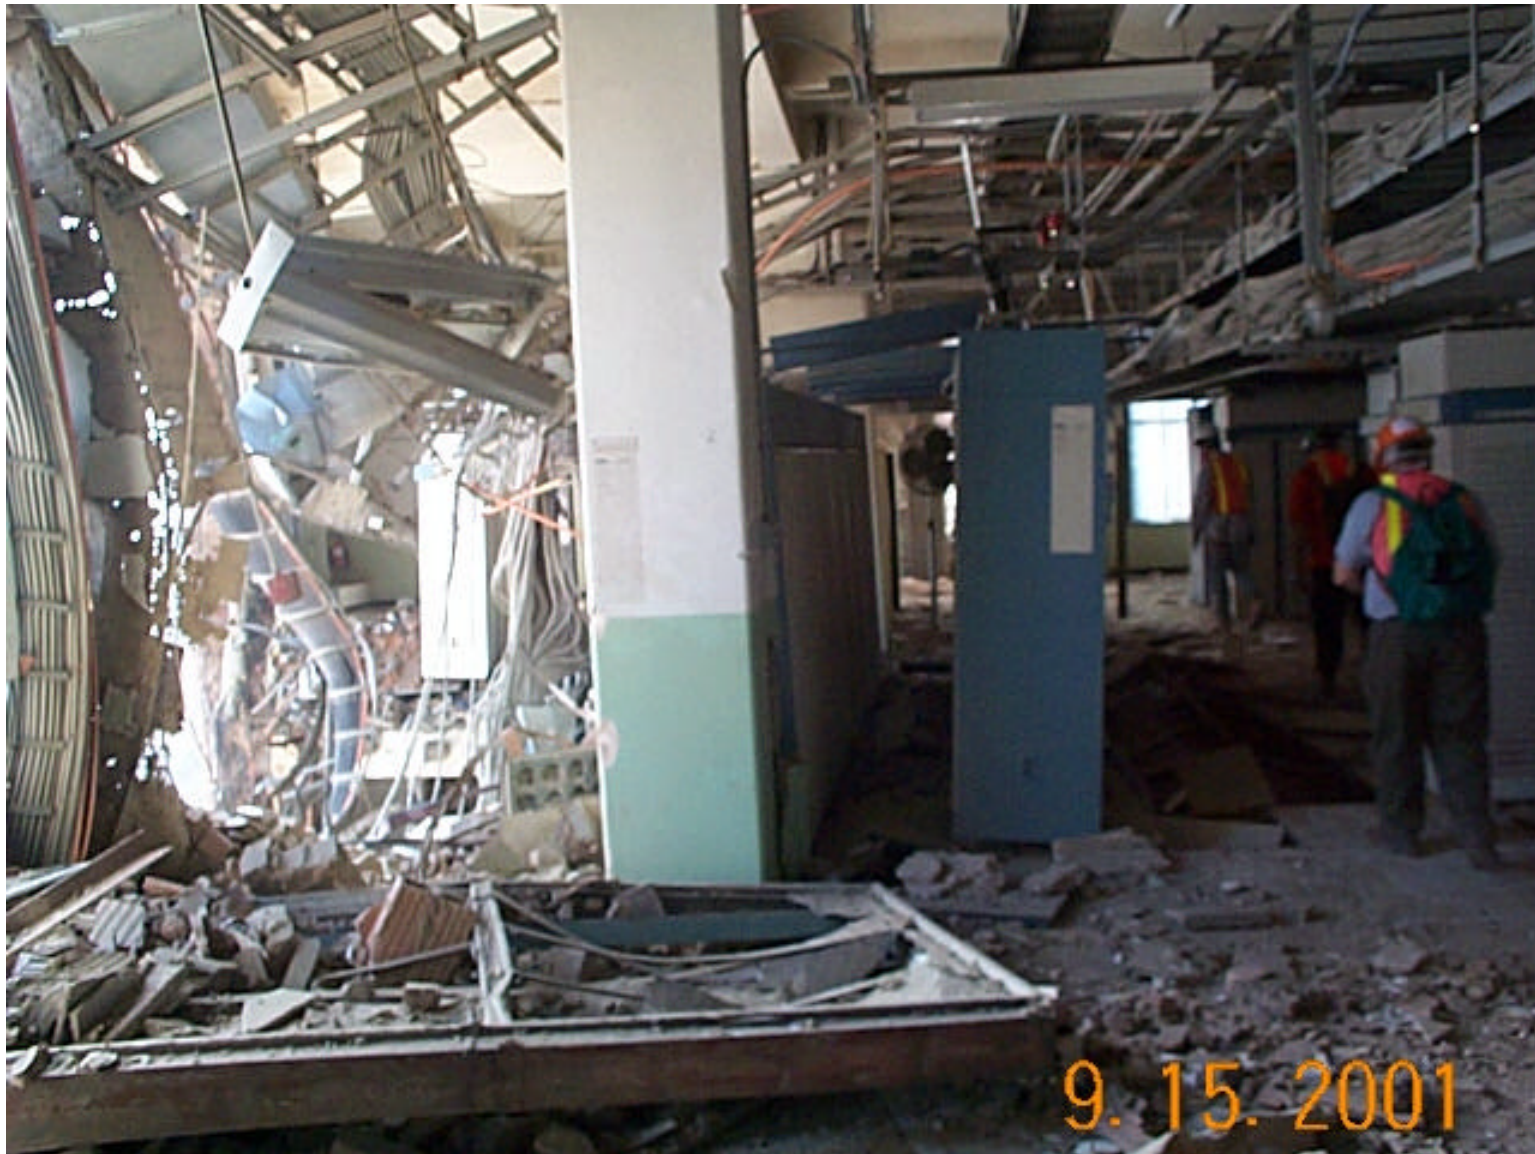
5ESS on the 7th floor in the southeast corner.

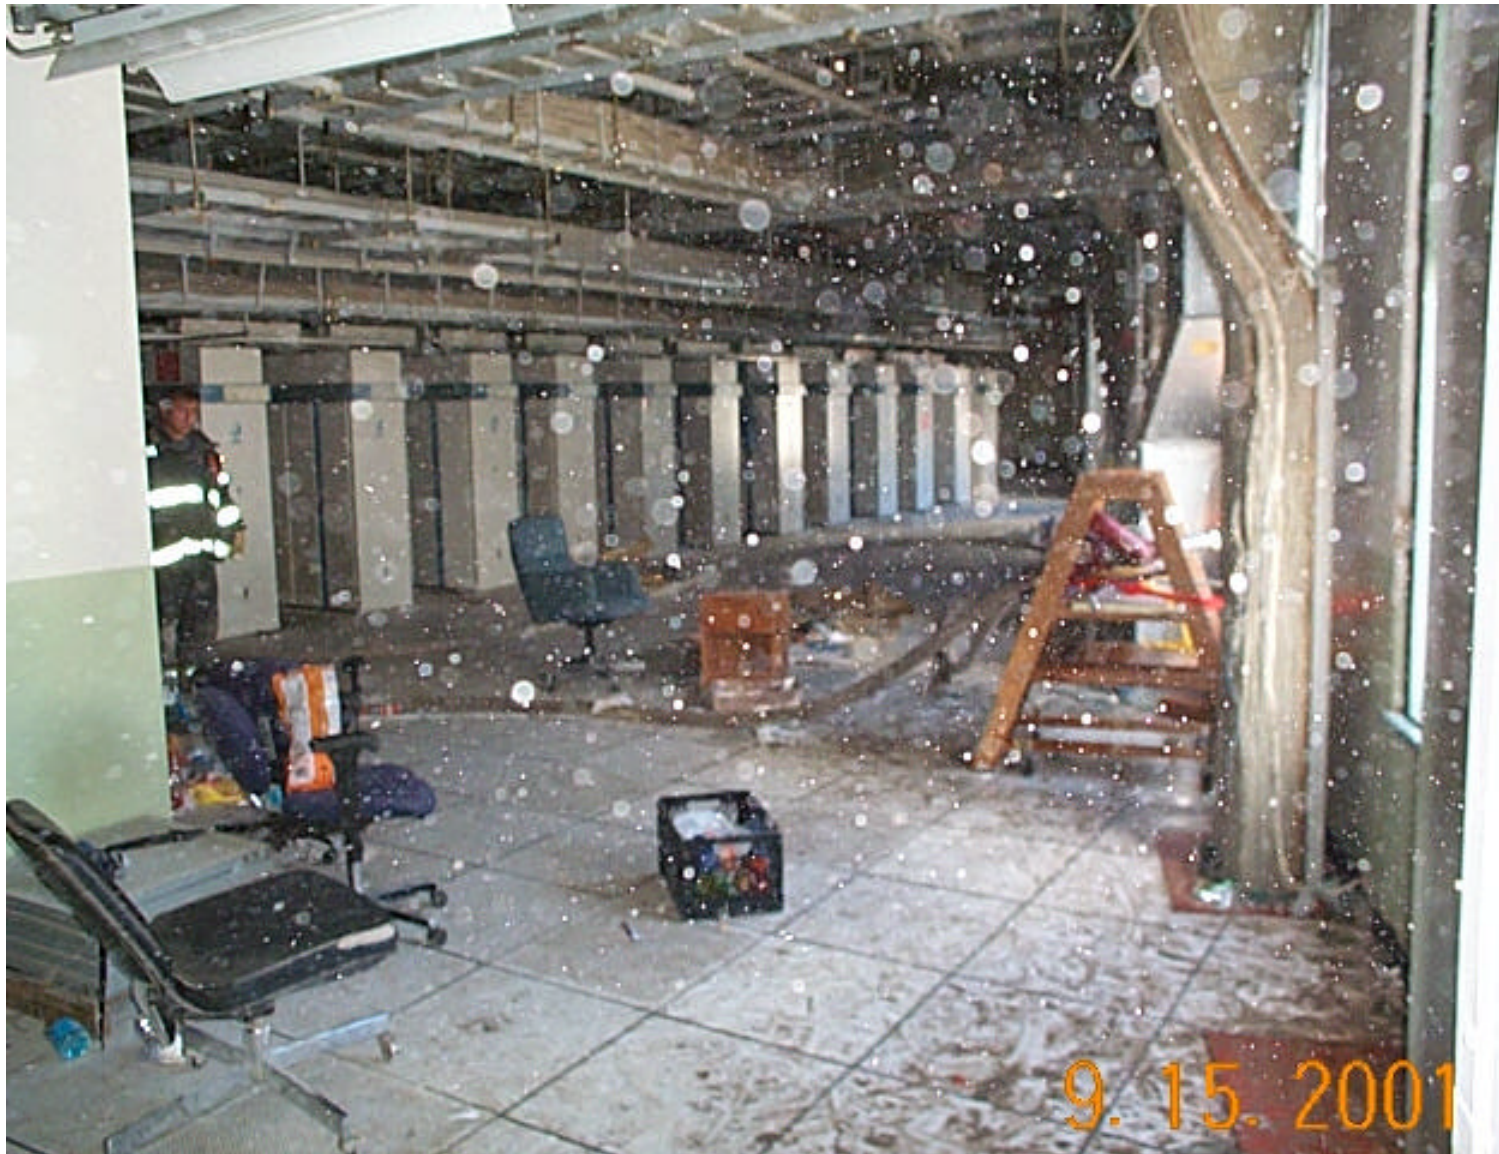
5ESS on 7th flr. Note fire hose in ladder at window.
Spots caused by water spraying around.
